# FACILITY COMPLIANCE INSPECTION REPORT

## Division of Waste Management Solid Waste Section

**Date of Site Inspection:** January 24, 2013 **Date of Last Inspection:** December 14, 2011

Murray LCID Landfill  
5352 Friendship Rock Creek Road  
Snow Camp, NC 27349

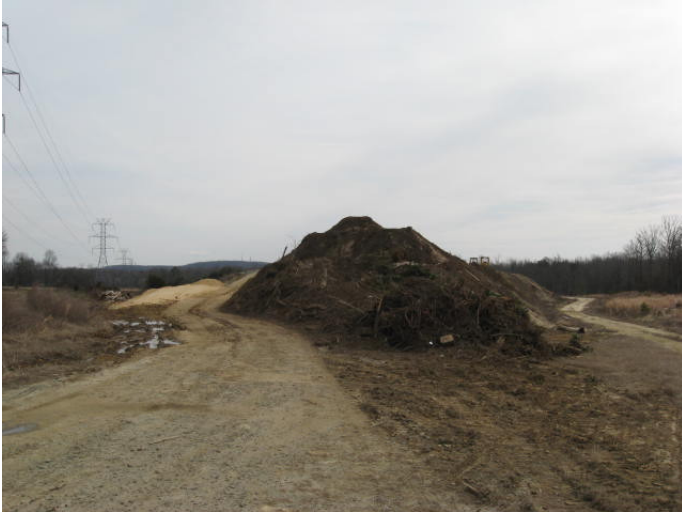
12. The working face is restricted to a small area.
13. Unpermitted material pulled from incoming loads is stored in a pile adjacent to the landfill. Mr. Murray stated that the unpermitted material is routinely disposed of properly.

14. Access roads are of all-weather construction.
15. The facility is secured by a steel cable and padlock.
16. The facility has proper signage.

Access road atop landfill, view of working face

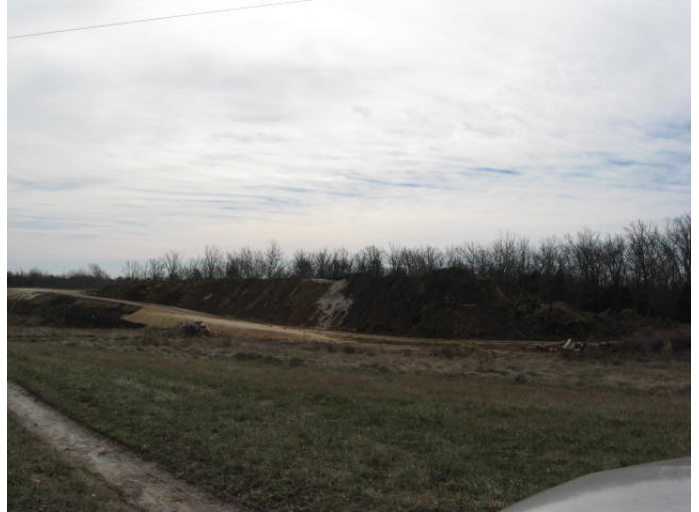
7. The landfill cap, including side slopes, is adequately covered with soil.
8. Soil from the adjacent mine is being placed atop the entire landfill.
9. Side slopes should be graded such that a 3:1 slope ratio is obtained or a ratio of which no indication of erosion or runoff is observed.

Landfill, left side slope view

10. Mr. Murray stated that the landfill side slopes will be graded according.
11. Groundcover sufficient to restrain erosion shall be established on inactive areas.

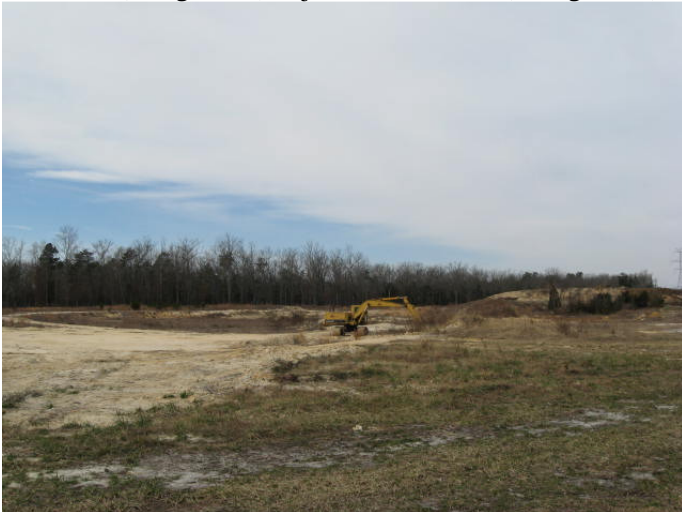
2. The LCID landfill is estimated to be  $\leq 2$  acres.
3. Mr. Murray operates a soil mine adjacent to the landfill (he stated that approval was sought for the mining operation). He intends to convert the area to a pond.

Soil mine (foreground) adjacent to landfill (background)

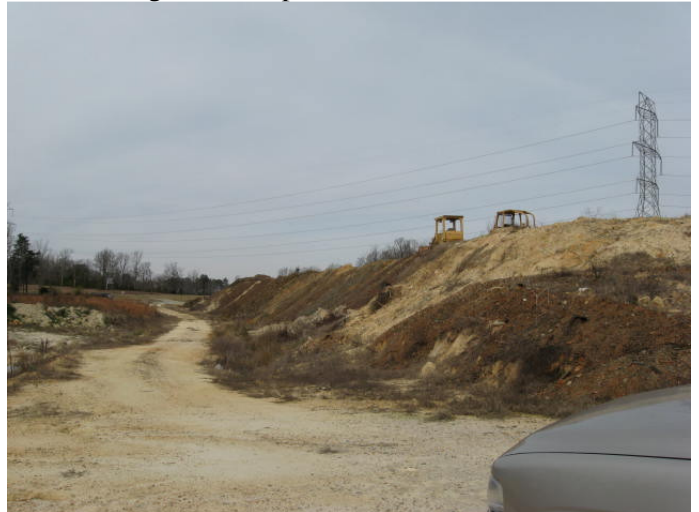
Landfill, right side slope view
